Treasure Island – Lake Fairlee

Lake Wise Evaluation

Date: 8/10/2022

Address: 1218 Rt.244, West Fairlee, VT

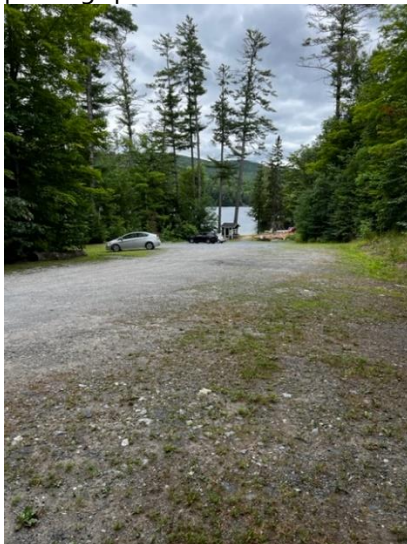
The area of parking by the gray car is very wide. Consider adding some logs to reduce the overall width without sacrificing parking spaces.

Driveway Area: The parking area is in surprisingly good shape given the size and slope. The water bars that divert water into the wooded buffer are functioning and not leading to additional erosion. The overall size of the parking area is a little excessive. Perhaps adding some large logs similar to the ones that are there could help to reduce the overall width of the area without reducing the number of parking spaces.

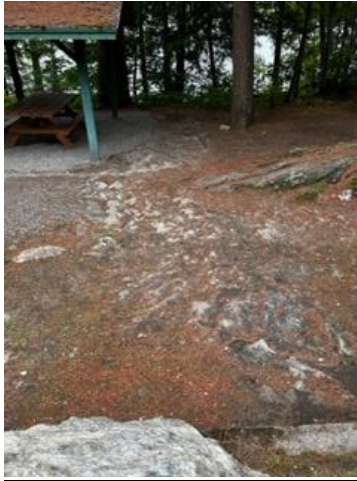
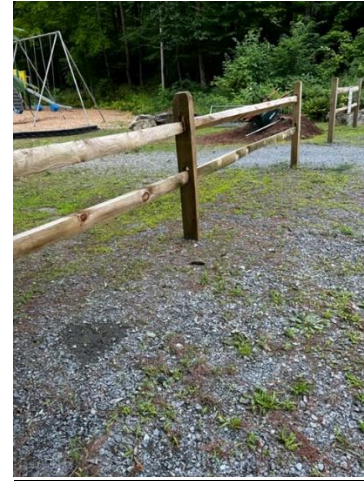
One area of concern is at the bottom of the parking near the ticket booth and off to the side over the retaining wall toward the picnic pavilion. Evidence of water flowing off the parking and around these areas has formed channels and deposited sediments. Planting native shrubs or a rain garden along the

The lower end of the parking area shows signs of erosion from the volume of water that flows across the parking. Adding a rain garden or shrubs in these areas could help slow the flow of water and trap sediment before it enters the lake.

retaining wall and split rail fence could be used to slow the flow of water, trap sediment before it enters the lake and add an attractive entrance to the beach area.

It is important to maintain the access road and parking area. Keeping the access road crowned to divert water into the wooded areas, maintaining the water bars to divert water into the vegetative buffer and keeping the bare dirt covered with gravel (it looks like this has been recently done at the lower area of the parking) will go a long way to maintain a stable parking area with the least impact to the lake.

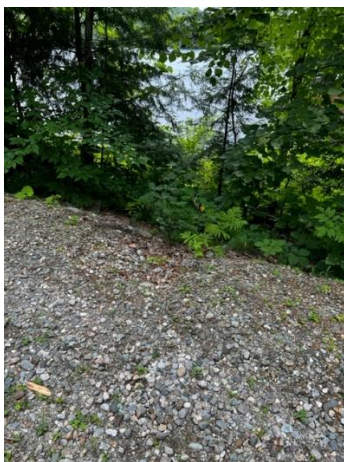
The access road next to the basketball court is unstable from runoff and the sediment is very close to the lake. Refer to the new Vermont Bioengineering Manual for guidance on stabilizing this slope.
https://dec.vermont.gov/sites/dec/files/documents/BioEngineeringManual_Final.pdf

The access road along the basketball court to the Island shows signs of instability. Water flows off the court to that access road and almost directly into the lake. Use of large boulders or an erosion control mat could be used to help establish vegetation long this steep slope. The other road coming down from the house toward the causeway is also showing signs of erosion. This area needs to be regraded with the addition of water diversions to send sheet flow into the wooded area and help reduce the movement of sediment into the lake.

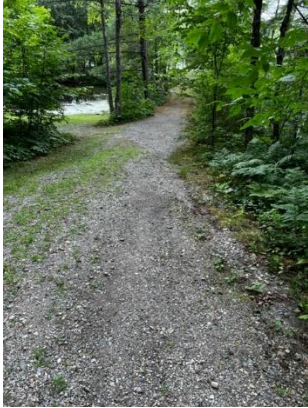
This portion of the access road down from the house toward the causeway is showing signs of channelized erosion. The road needs to be reshaped to divert water into the wooded areas and slow the flow of water before it enters the lake.

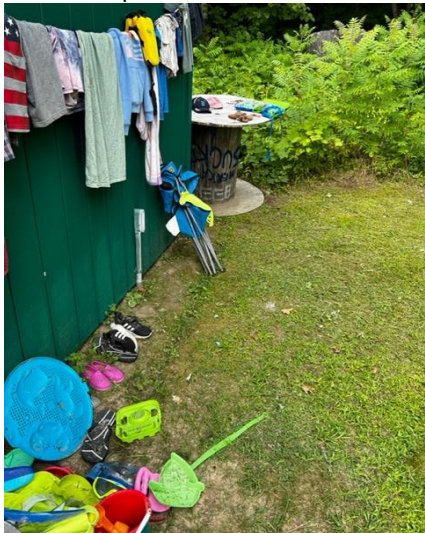
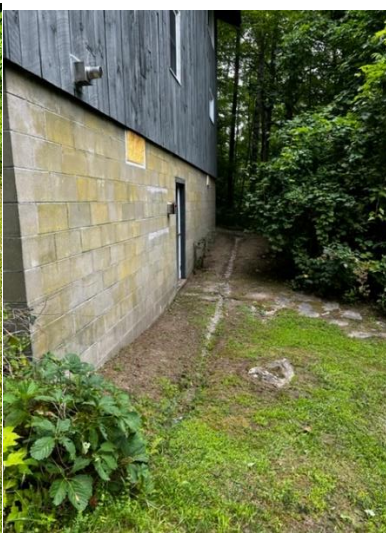
Areas like the side of the First Aid station, the bathhouse and the front of the main house would benefit from a drip line trench of gravel to trap water from the roof and allow it to infiltrate.

Structures: There are many structures throughout the property of varying sizes. The park has done a great job reducing mowed areas and maintaining the natural vegetation and duff layer around these buildings to slow the flow of water from the impervious roof surfaces. However, along the front of the main house, and along the drip edge of the bath house and first aid station a dripline trench could be added to allow water to infiltrate the ground (see attached Guidelines about dripline trench construction). These areas (especially those closer to the beach) are heavily used, exposed dirt is visible and evidence of erosion was observed. Catching water from the roof and allowing it to be absorbed would help reduce the movement of sediment in this area close to the beach and the lake.

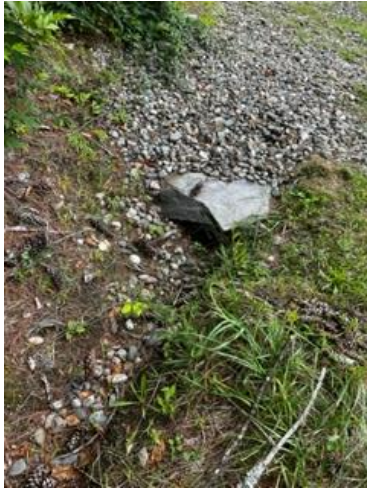
The outflow of the gravel drain around the beach is effectively reducing the movement of beach sand into the lake. The outflow of the drain would benefit from a rain garden or drywell to trap the water and slow its flow before it enters the lake.

The gravel perimeter around the beach is doing a good job diverting water and reducing the movement of sand into the lake. At the outflow of this area there are piles of unused docks and boat racks. Installation of a rain garden or a gravel dry well in this area could help filter the excess water before it enters the lake while also enhancing the look of the beach.

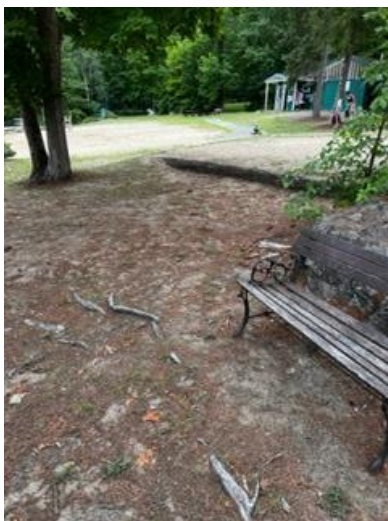
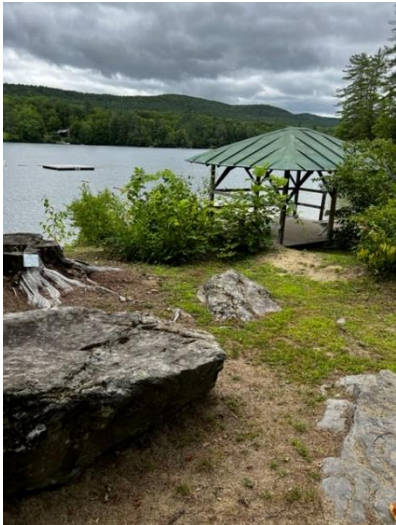
Left: Sand from the volleyball court is migrating over the small retaining wall and towards the lake.
Right: This area close to the volleyball court needs defined pathways and plantings to allow native vegetation to re-establish and filter sediment before it enters the lake.

The sand volleyball court is very close to the lake and has somewhat overwhelmed the retaining wall on the lake side. Improving the retaining wall and enhancing the buffer plantings in this area would be very beneficial. The entire area between the beach pavilion, the large stump and the volley ball court could be improved with defined pathways and native plantings. This area receives a lot of use and defining the pathways to direct traffic and allowing the native vegetation to establish would be very beneficial to protecting the lake from sediment.

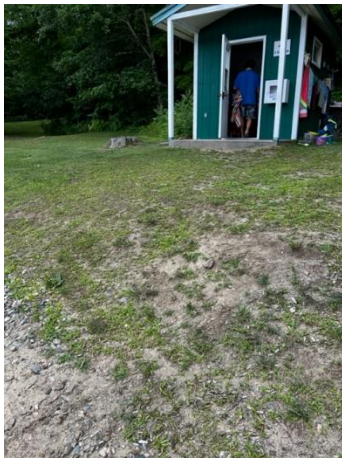
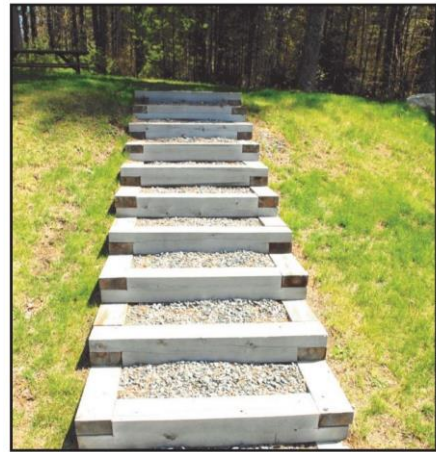
Bare earth in front of the First Aid station could be reduced with simple infiltration steps like the ones to the right that allow water to soak into the ground and guide traffic.

Many of the beach area recommendations were addressed in the recreation section. The slope leading up to the first aid and bath house is compacted and bare earth is visible. This area is mowed very short and receives a lot of foot traffic. Unfortunately, compacted short grass is not effective for slowing water or improving permeability. Defining pathways and increasing permeability with deep mulch or crushed stone would help to slow the flow of water in this area. The addition of infiltration steps up from the beach to the bath house area could also be used to direct traffic and allow stormwater to infiltrate.

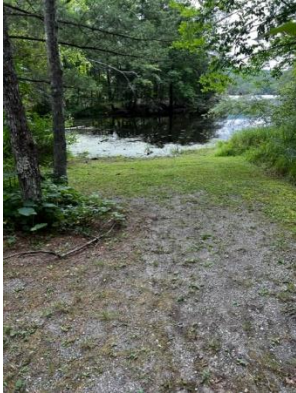
Mowed area next to the causeway. Is this used anymore? Or could it be designated a no-mow area to help filter run-off from the access road.

Just before the causeway there is a mowed area that goes down to a mucky access point. Historically, I was told this was a boat launch but it is not clear if this area is used any longer. Perhaps this could become a no-mow zone and the natural vegetation could be allowed to re-establish. If the area is still used, then perhaps it doesn't need to be as wide. At the moment runoff from the access road enters the lake at this point.

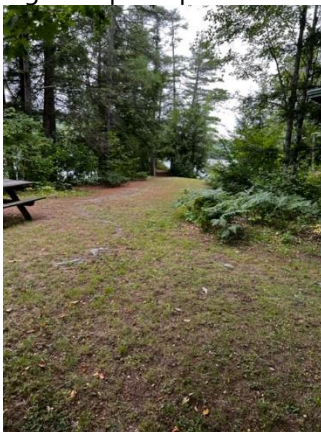
This large mowed area heads south past the latrines out to a point. Defining a trail with logs or stones and designating no-mow areas would help restore this area without significantly reducing the recreation space.

The native vegetation that is on the island is generally healthy and the parts of the shoreline are naturally armored with bedrock-- all of which is great. This is a popular area but it would benefit from some careful alterations. As I mentioned, removing the latrines would be an excellent start to protecting water quality. There is also a large mowed area that heads south out to a point. Defining the area past the latrines as a narrow path would not reduce the recreation area significantly and would help enhance the lake buffer zone. By creating a no-mow zone and defining the pathway with some logs and perhaps mulch would be an effective and low cost way to achieve big results.
