Treasure Island Stewardship Plan 2023-2033

Lisa Niccolai
Leaf2landscape Consulting

June 8, 2023

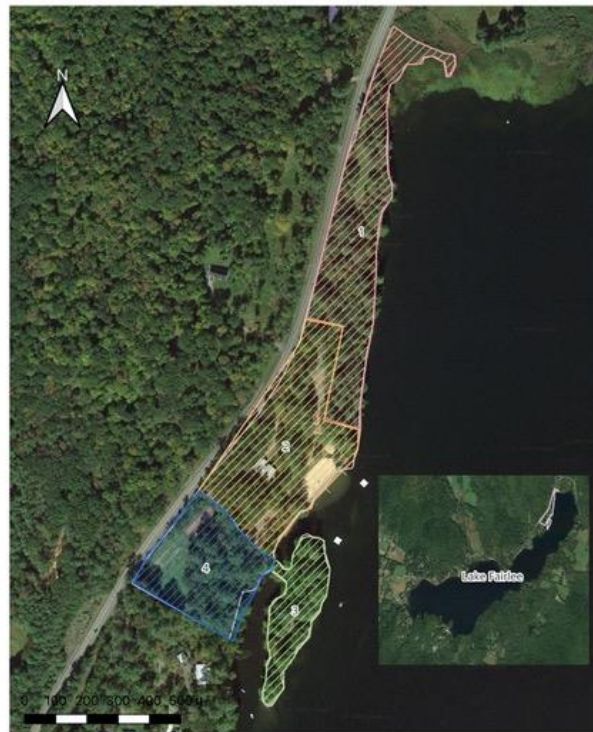
Figure 3 Treasure Island Management Units

For planning purposes, Treasure Island has been divided into four Management Units (MUs). Each management unit was delineated based on habitat type, use areas, and physical features. Figure 3 shows the location and extent of the management units.

MU3 is the area known as Treasure Island. Although not technically an island, this area is attached to the mainland by a causeway. MU3 is heavily used and will require restoration to restore the balance of human use, protection of water quality and ecological benefits to the lake.

MU4 is the southern-most unit. This area is designated as a more rustic recreation area with paths, fields and a few rustic picnic areas. The unit includes a wooded areas at the southern end of the property.

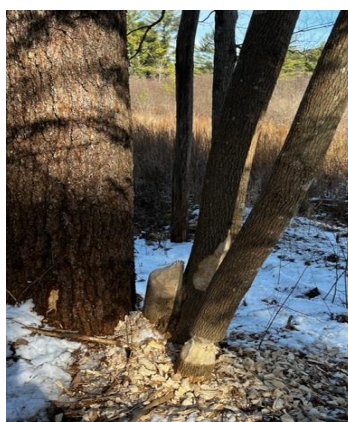
Figure 13 Recent beaver activity near the wetland at the north end of the property.

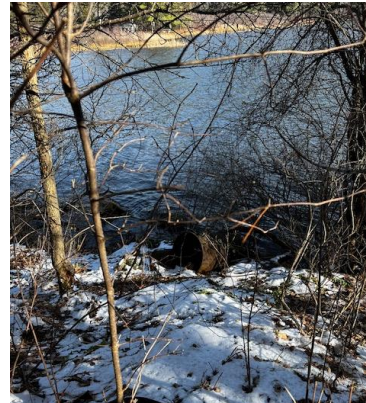
To further enhance the habitat value of MU1, the miscellaneous debris in this area should be addressed. There is a pile of rebar and plastic left after an aquatic treatment that was conducted in the past. Selling or reusing these materials may generate a little income and get them off the property. There is also a brush pile that contains dimensional lumber that should be removed or burned. An old dock is fastened to the shoreline and partially sinking. It is adjacent to a beaver lodge. The dock should be examined to see if the flotation material is disintegrating Styrofoam. The dock may be providing some habitat but it may be polluting the lake. Removing this dock would likely be the best course of action. At the very southern boundary of MU1 is a barbecue grill near the art shack. While not exactly debris, this may not be the most appropriate location for picnicking. Removing the grill and re-directing this type of recreation to other areas of the property could be helpful to restoring the shoreline. The grill area is a large compacted area that will require some native plantings to help restore the area.

Figure 15 Old junk found on the property.

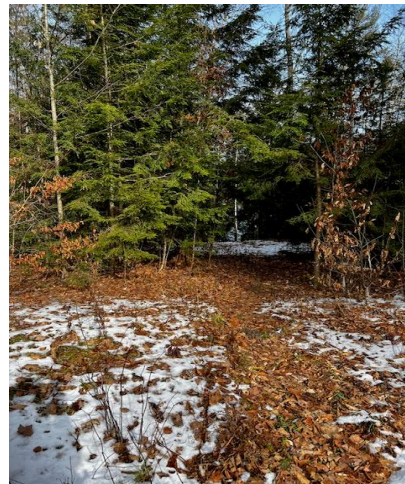
There is an unmaintained trail that follows the shoreline. It appears to exist due to visitors who explore the shoreline. Its location immediately adjacent to the edge of the lake is less than ideal. Compacted soils and trampled vegetation may be prone to erosion and detrimental to that lakeshore habitat. A decision to re-route the trail or to dissolve it needs to be determined. If the trail is to be kept it should be relocated back from the shore, the natural duff layer should remain intact and access to the lake should be limited to defined areas that are naturally armored with bedrock. Guidelines on path construction near lakes can be found in in Appendix 4.3. If the decision is made to abandon the trail, then a restoration effort is required to block the trail, replant areas that area badly compacted or eroding and re-direct visitors to more appropriate areas of the property. There is an undeniable appeal to scrambling along the shoreline so eliminating this trail is likely to require careful consideration and ongoing efforts.

Figure 16 An unofficial trail that hugs the shoreline.

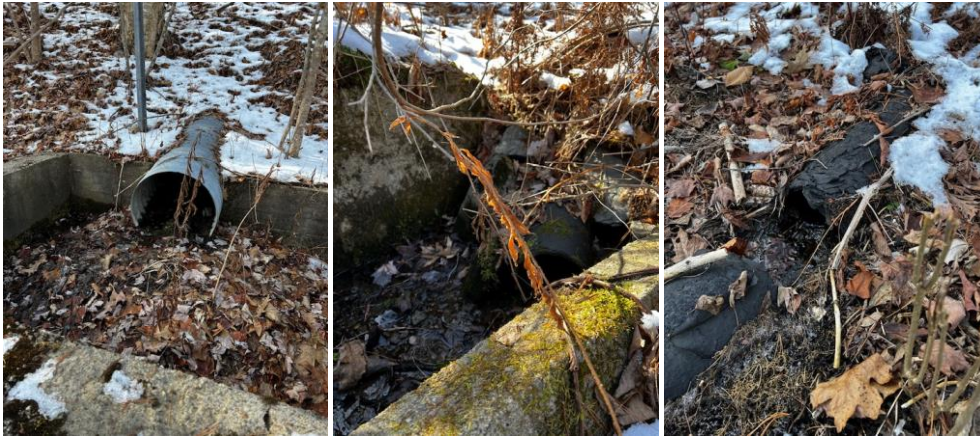
Figure 17 Culverts and drains on MU1

The Town of Thetford has contracted with an engineering firm to have the wetlands delineated at Treasure Island. When the report is released there may be additional projects that are identified. Regardless of the findings, it is clear that some of the drainage has been altered in MU 1. There are culverts under Rt.244 that flow into large cement box culverts that may have been drinking troughs for livestock. There are also old drainage pipes that surface close to the shoreline. Restoring the

natural hydrology of the site may be a large undertaking. It would require additional studies, permitting and significant fundraising, but could be an important step to restoring the habitat of MU1. In the short-term, covering the exposed pipes and cement boxes is an important safety step for both humans and wildlife.

Issue	Description	Action	Priority	Duration
Invasive Species	Small population of barberry and honeysuckle	Remove manually and dispose of carefully	High	Ongoing monitoring will be essential
Rebar + Plastic	Materials that were left from the invasive treatment in the lake are piled near the shoreline	Sell	High	Short term dispersal
Miscellaneous Junk	Organic material as well as lumber piled in the meadow and on the shore	Remove and/or burn	High	Short term dispersal
Shoreline Trail	Trail is damaging shoreline habitat	Relocate or block	High	Will depend on the action
Culvert and Pipes	Perhaps old animal watering as well as remnants of other drainage	Safety concern, cover or remove	High	One time action

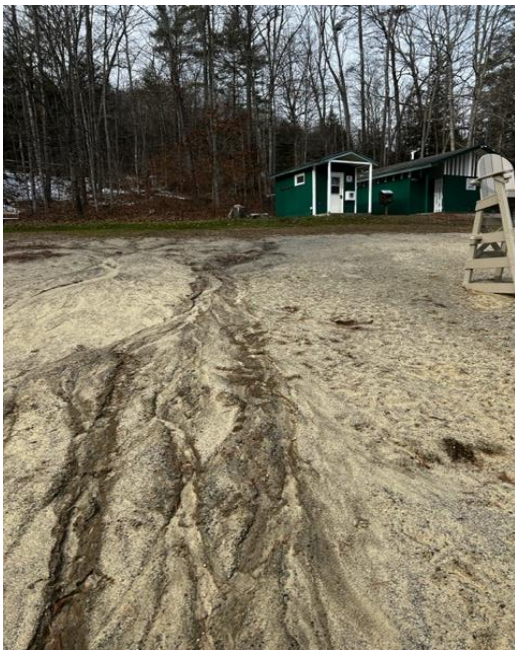
Figure 18 LakeWise focused on addressing erosion issues related to storm water. This picture illustrates the issue of stormwater carrying sand from the beach into the lake.

Management Unit 2 contains the majority of the developed recreational area including parking, buildings, mowed lawn, sand beach, playgrounds, volleyball court, basketball court and access roads. There are a few remnant patches of trees along the road and around the main house. The majority of this Unit is dedicated to recreation and the duff layer is generally removed and the soils appear compacted. As such, erosion was observed from stormwater moving across the parking area and picking up sand from the beach and volleyball courts to transport into the lake.

Excessive Parking	Stormwater flow down to beach	Limit size, maintain water bars-See LakeWise	Medium	On-going
Sand from volleyball court eroding	Stabilize volleyball court	Improve retaining wall and enhance	Medium	Repair and install

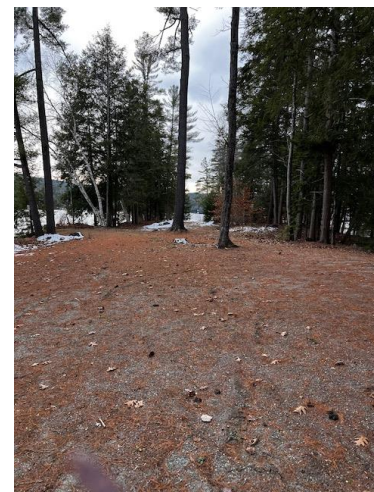
Management Unit 3 consists of the causeway and island area. The topography is very flat, the soils are compacted and the duff layer has been largely removed by landscape clean-up crews. Much of the understory has been removed leaving an overstory of hemlock, pine and oak with some beech in the understory. Most of the snags and downed coarse woody debris have been removed. The canopy is open due to a large cleared area in the middle of the island.

The “island” area is a wonderful hemlock, pine and oak forest that is in danger of being *loved to death*. Currently the overstory trees provide shade but the forest floor and mid-story have been mostly removed in large areas. The first step to restoring the Island area is to determine appropriate use. The entire middle is cleared and compacted. What size groups gather here? Could the clearing be smaller and still be effective? The outhouses are redundant and may be scheduled for removal. This is an important step to protecting clean water in Lake Fairlee. The barbeque grills are old and outdated. Could they be rebuilt and carefully placed to concentrate visitors in a few areas. Instead of mowing a large area and removing the natural duff in an effort to “clean up”, define the areas with edging and limit clean up to areas where it is appropriate for people to gather.

Figure 19 Excessive cleared area and lack of duff layer in need of restoration on the island.

Designing the outdoor spaces will require planting appropriate native plants and a delineation between where people and the landscapers should be, and where nature should be allowed to grow. For example, there are several areas with rock outcrops that invite visitors to the water’s edge. Focus access to these naturally armored areas and install native plantings with low log or rock edging to keep people from trampling new plantings. Exploring the point of the island is a wonderful experience, but the path could be reduced to a narrow 3 ft winding track instead of the wide mowed area that heads in that direction now. Placement of the grill area near the causeway and the existing open area as well as some landscaped

Issue	Description	Action	Priority	Duration
Compacted shoreline soils	Trampled shrub layer	Define water access and plant native shrubs	High	Initial design and implementation
Latrines	Unsanitary and bad for water quality	Remove and redirect people to public bathrooms	High	Remove and cap
Excessive mowing and leaf blowing	No duff layer and unnecessary mowed areas	Communicate with landscapers to reduce mowing and removal of duff	High	Likely will have to be reminded over time
Invasive Species Removal	Honeysuckle is growing along the causeway	Pull and replant with natives if needed to stabilize the path	High	Monitor over time for new plants

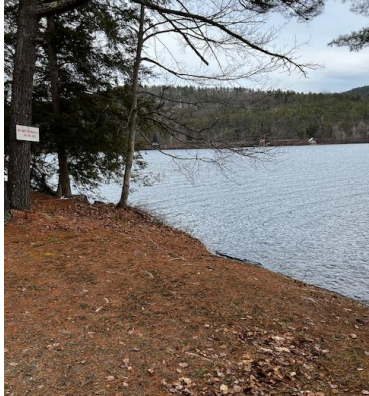
Figure 20 Define pathways to access the water in appropriate locations instead of large cleared areas that are there now.

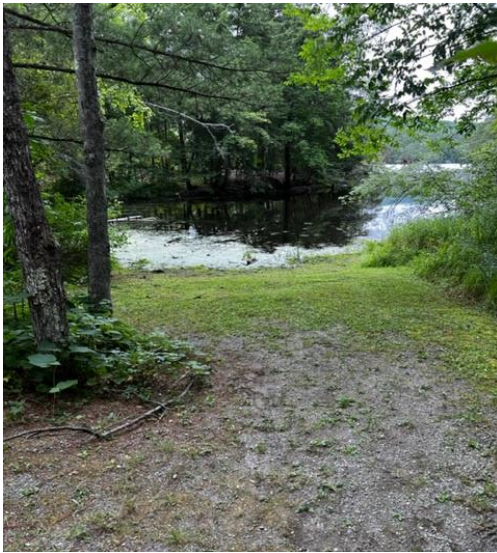
MU4 is partially forested with a mix of white pine, oak, beech and birch and a healthy understory with a thick duff layer. The access road to MU3 defines the northern border of this Unit. Closer to Rt. 244 is an open area that is part meadow, clay tennis court and septic system. At the southern corner there is a gated access with a gravel apron allowing direct access to the meadow for mowing or maintenance. Most of the area is wooded and providing an excellent shoreline habitat. Adjacent to the causeway there is a large mowed area that was once used to launch boats. The cove is rather mucky and there may be better areas for boat launching. Determining if this area of shoreline could be reduced in size or abandoned to regrow would help trap stormwater that flows down the access road.

Figure 21 A large unused mowed area that allows sediment to enter the lake. Could this be replanted or reduced?

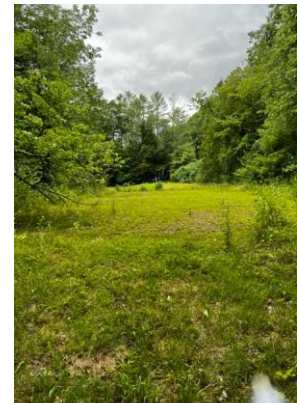
The field and clay court close to Rt.244 offer interesting potential for activities. The clay court appears to be in acceptable condition if there was interest in restoring it to be fully functional as a tennis court. This would require a commitment from the Recreation Department but it is an interesting resource that could draw additional people to use the property. The meadow may also offer opportunities. It could be mowed on a more regular basis during the summer to provide a

Figure 22 Open meadow area and tennis court close to the road with potential for additional uses.
